# Fitbit Surge Touchscreen Sensor Replacement

This guide provides instructions on how to replace the touchscreen sensor in the Fitbit Surge.

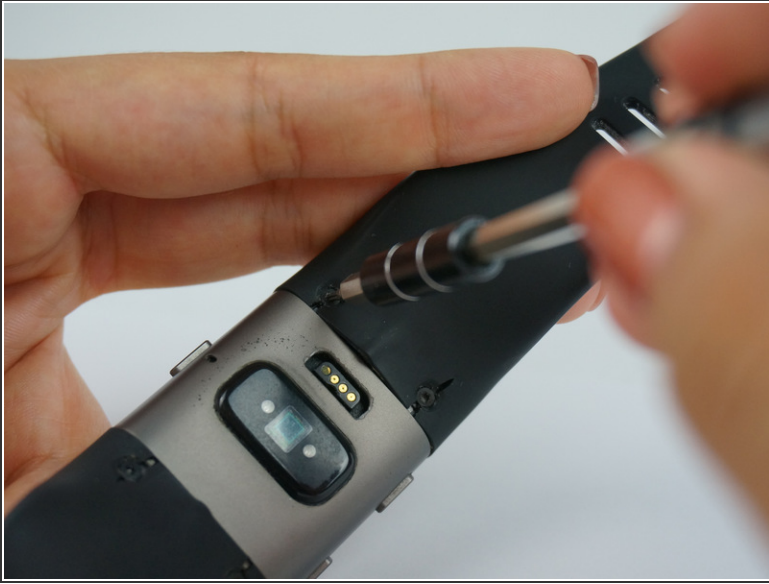
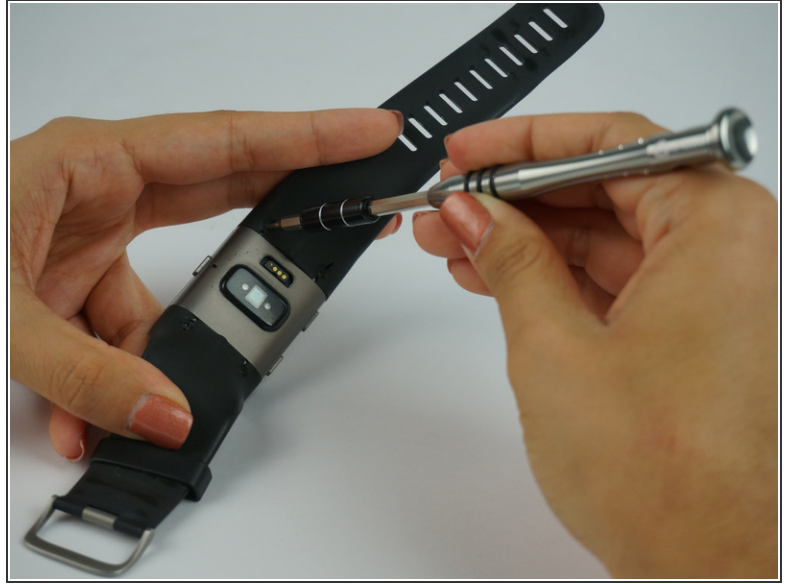
## Step 1 — Touchscreen Sensor

- Unscrew all four black 3 mm screws on the underside of the watch using a T5 screwdriver.

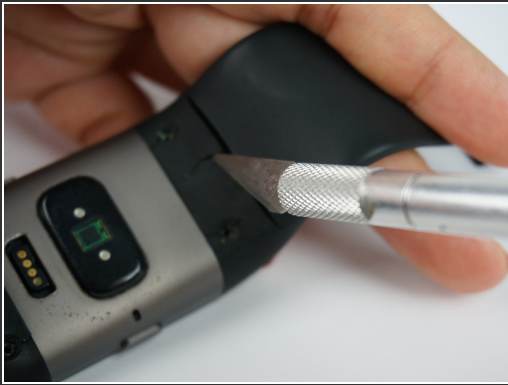
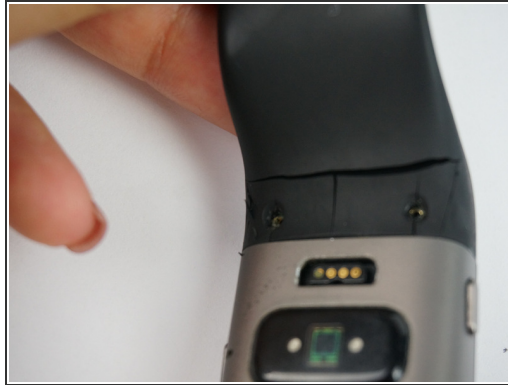
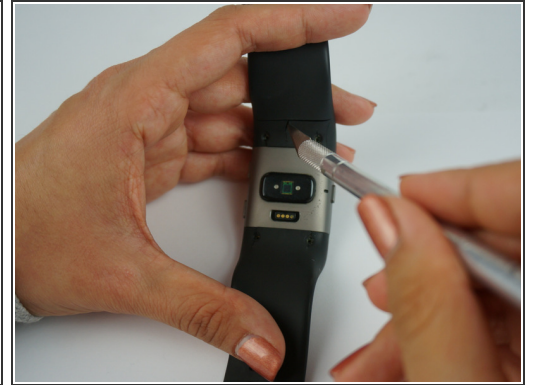
## Step 2

- Use an X-Acto knife to cut the band above, on either side, and in between the 2 screws.
- **Note:** Part of the band is hard plastic.
- **Caution:** Once the band is cut it cannot be reattached.

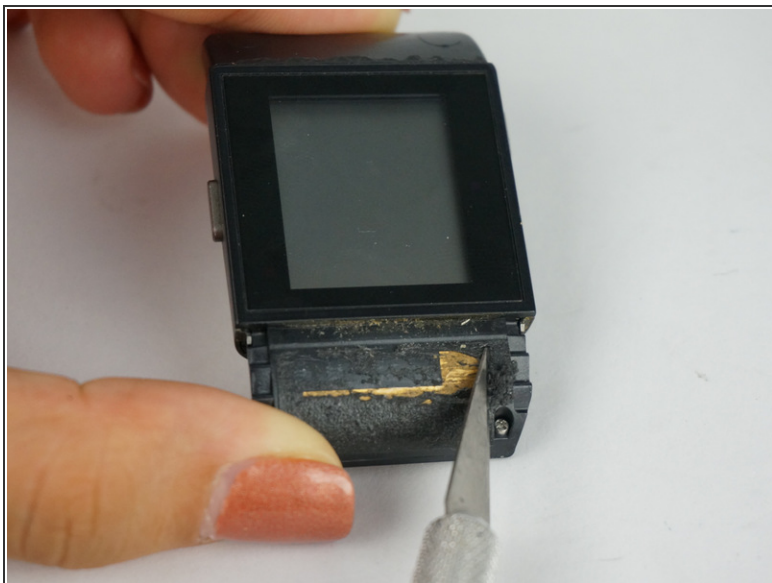
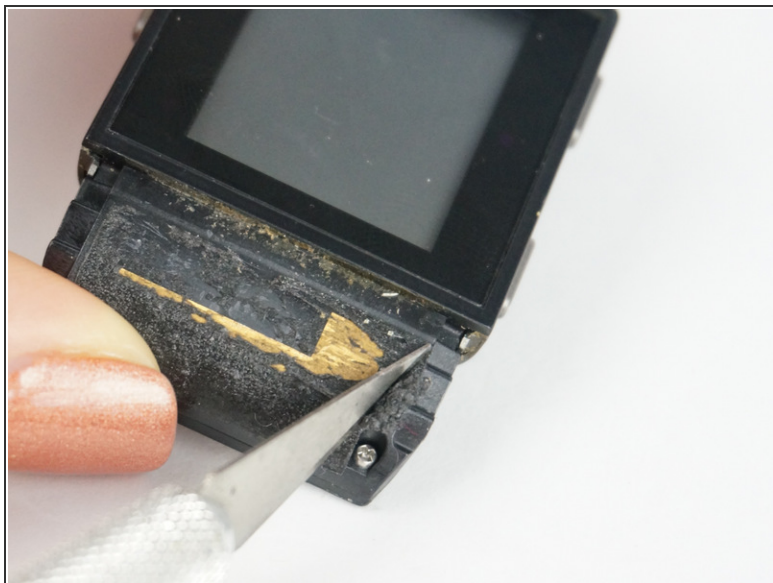
### Step 3

- Scrape away the glue beneath the hard shell portion of the band to reveal the GPS.

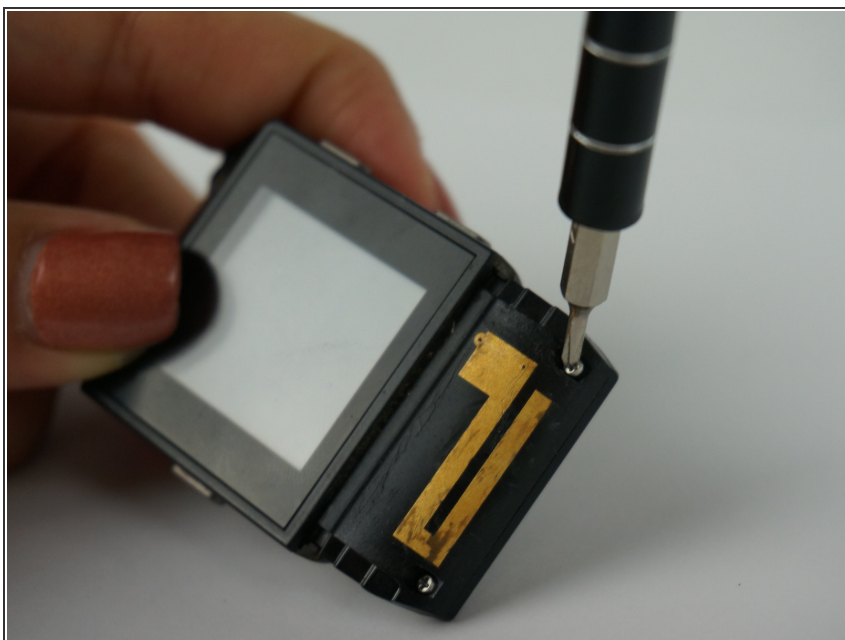
### Step 4

- Use a PH000 screw head to undo the newly revealed silver 4 mm Phillips screws that were hidden beneath the glue.

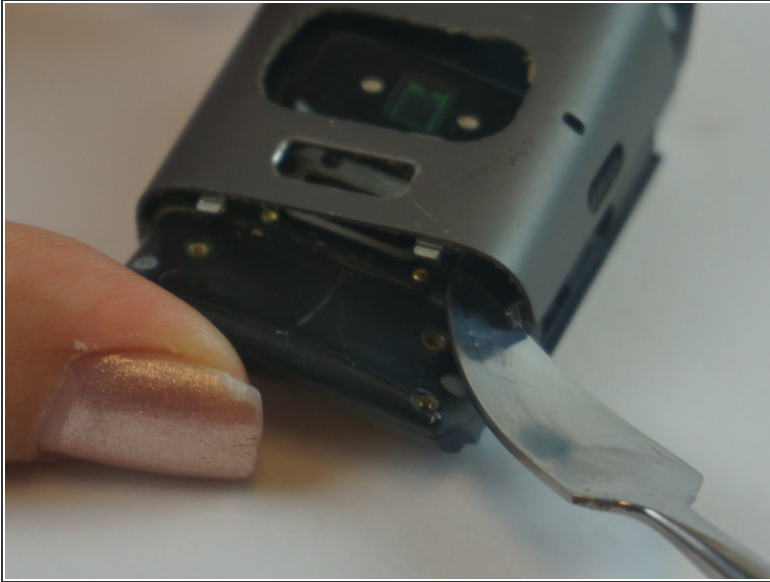
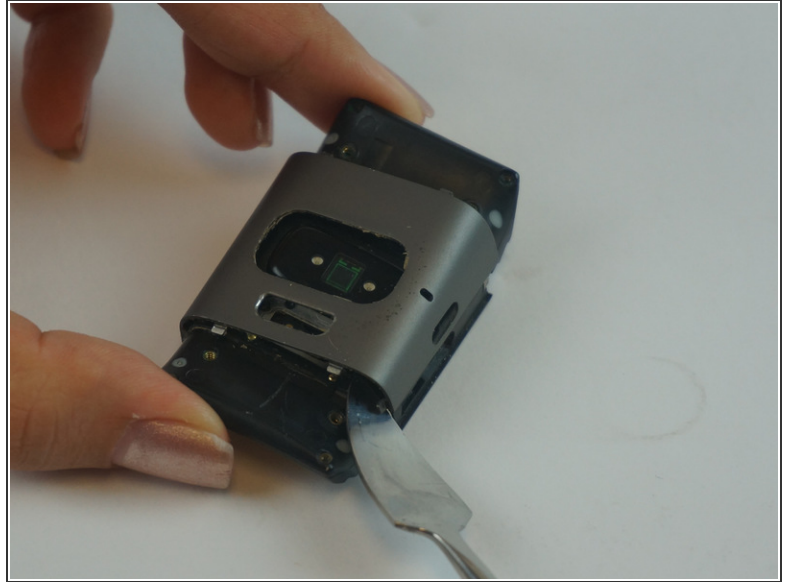
## Step 5

- Using a metal spudger, push down on the plastic gray square clamps on the underside of the device to dislodge the whole silver backing.
- **Note:** the buttons will also come off.

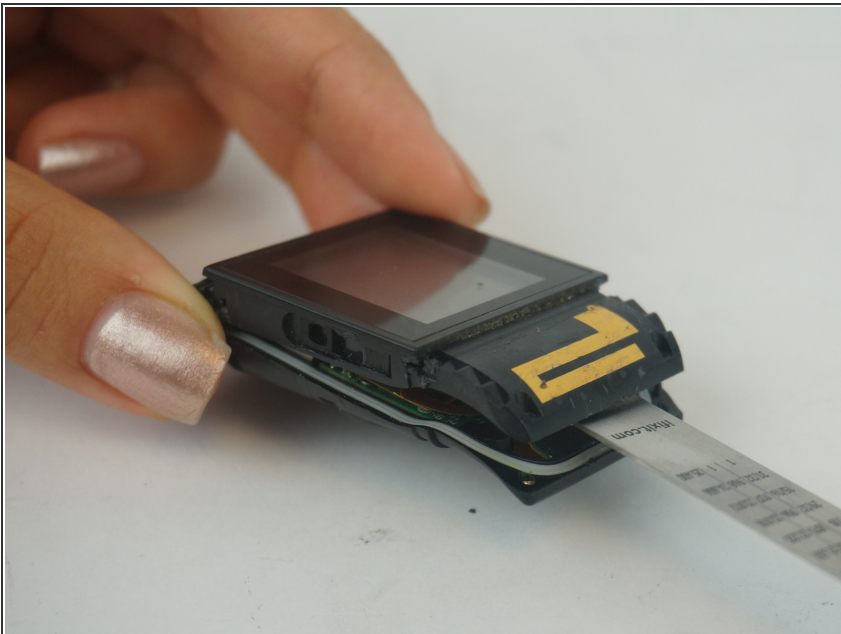
## Step 6

- Use a thin tool to pry the the device apart by lodging it between the clock face and back side of the device.
- **Note:** A spudger may not be thin enough to fit in the seam of the device. We used the 6 inch metal ruler from the Pro Tech Toolkit.

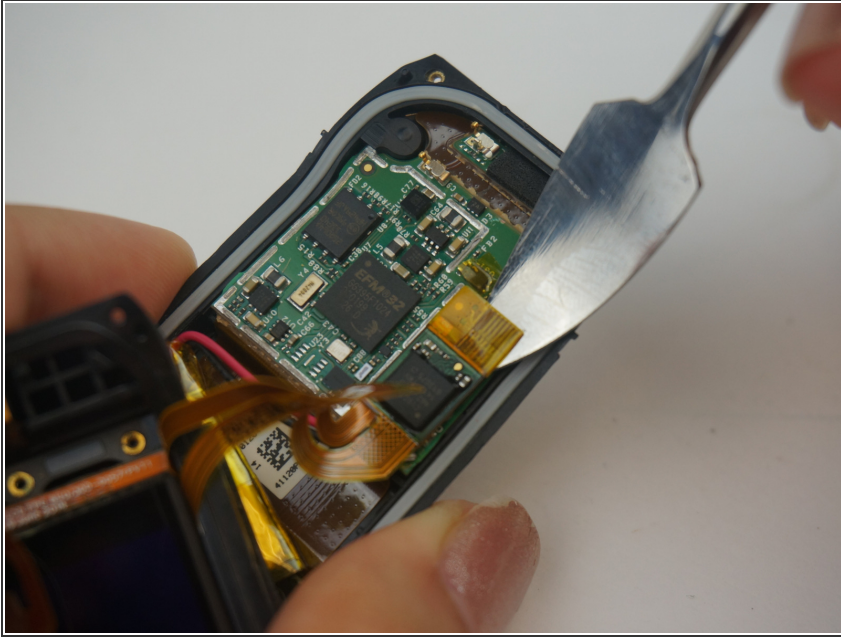
## Step 7

- Remove the touchscreen sensor using a spudger or your fingers.
- **Note:** In this photo we removed the metal cover on the main PCB, but you do not need to remove it for this guide.
